Materials Characterization of Explanted Polypropylene Hernia Meshes

C. R. Costello, 1 S. L. Bachman, 2 B. J. Ramshaw, 2 S. A. Grant 1

Received 18 September 2006; revised 9 November 2006; accepted 20 November 2006 Published online 6 February 2007 in Wiley InterScience (www.interscience.wiley.com). DOI: 10.1002/jbm.b.30764

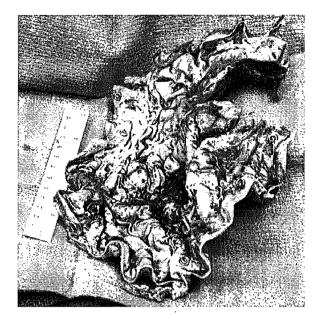
Figure 1. Kugel Composix hernia mesh immediately after explantation.

Polypropylene hernia repair materials were removed from patients requiring revision surgery due to chronic pain, recurrence, infection, adhesions, or other complications. An example of an explanted mesh is shown in Figure 1, and the contraction and embrittlement of the material are evident. The study was approved by the University of Missouri-Columbia's IRB committee, and each explant was given a sequential specimen number unrelated to any identifiable patient data. All 14 samples included in this study were the polypropylene components from polypropylene/expanded polytetrafluoroethylene composite hernia mesh such as Composix E/X or Kugel Composix (C.R. Bard, Cranston, RI), shown in Figure 2.
